NUTORK CORP.

Sample Description : LIMIT SWITCHBOX
SGS Ref No. : GZIN1512056728MR
Style / Item No. : NTS-CPXX
Sample Receiving Date : Dec. 29, 2015
Test Performing Date : Dec. 29, 2015 to Jan. 7, 2016
Test Performed : Selected test(s) as requested by applicant
Test Result(s) : For further details, please refer to the following page(s)

Summary of Results:

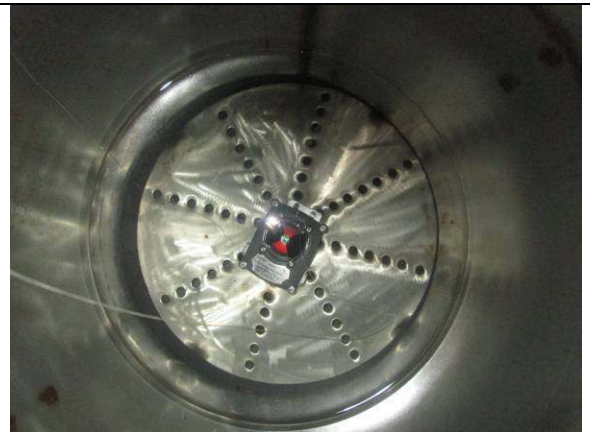
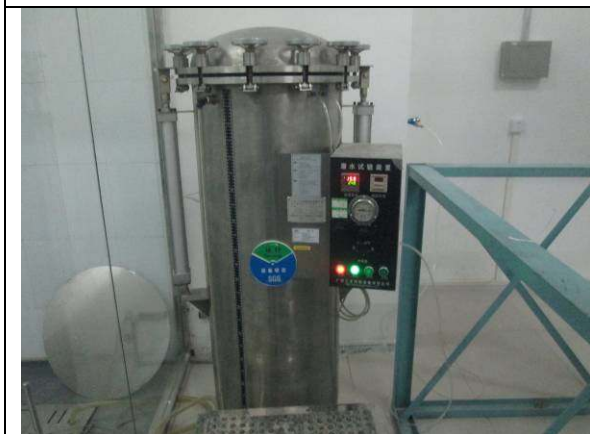
Depth: 50 m (0.15 m water depth and 0.5 MPa air pressure).

During Test
